# **The re-alignment afloat of a ship's main engine crankshaft using liquid nitrogen: The original repair re-visited**

RJF Hudson PhD., BAppSc., DMS., CEng., Extra First Class M.O.T  
FIMarEST., FIMechE., MCMI.

Using four tonnes of liquid nitrogen, the author recounts how the crankshaft of the MV Eastern Rover was successfully restored to operational alignment afloat. The bearing damage was also repaired and realigned afloat, with full cargo intact, at Moji, Japan, where the casualty occurred.

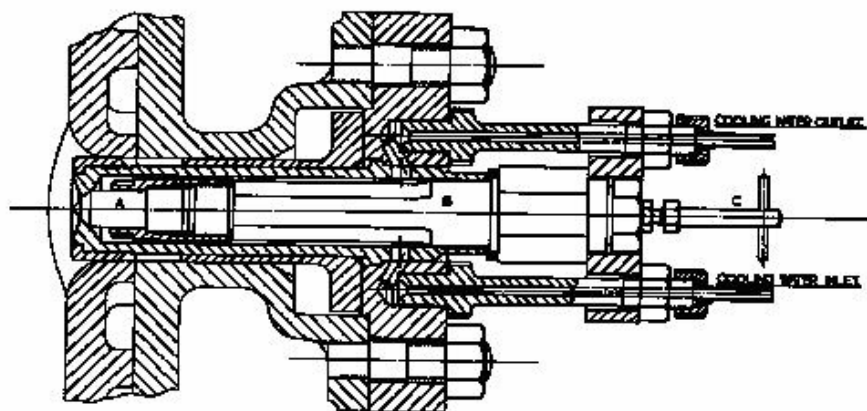
The author discusses the failure in service of the crankshaft of a 670mm bore Doxford LBD4 marine diesel main engine caused by cooling water leakage through minute cracks in a cylinder liner, adjacent a fuel valve. The water passed into the cylinder combustion space formed by two opposing pistons, in one of the cylinders. The hydraulic shock caused crankshaft journal slippage and major axial misalignment, with consequential main bearing and other damage. This occurred when the engine was wrongly tested using starting compressed air without first checking the main machinery by slowly rotating it once or twice, using the electric driven mechanical crankshaft turning gear.

Figure 4. Fuel valve/cylinder liner arrangement

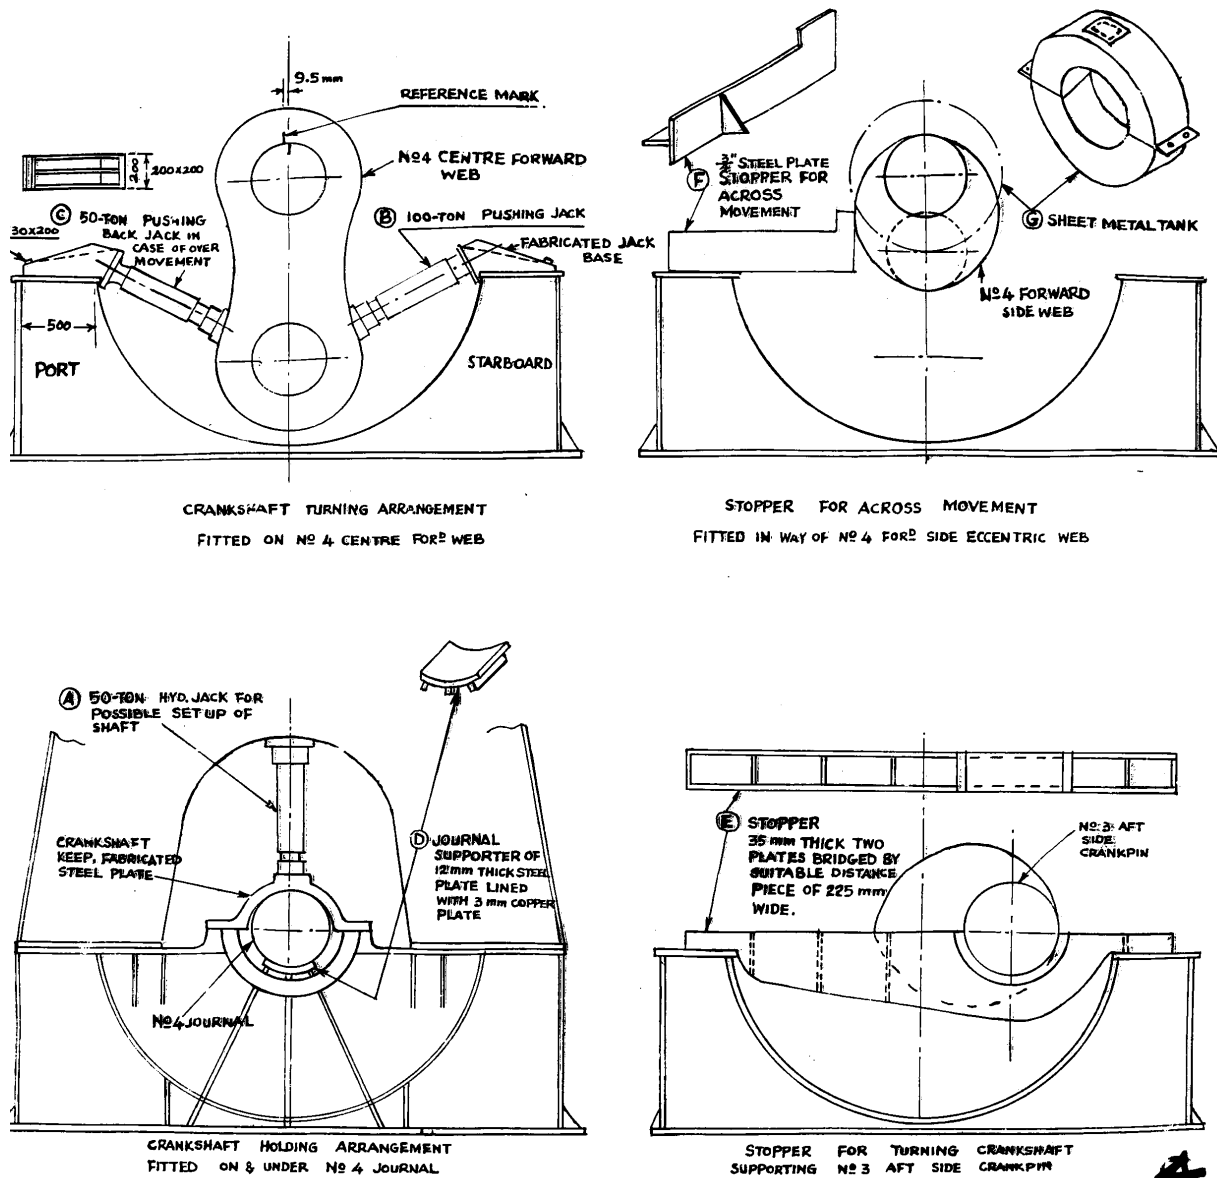
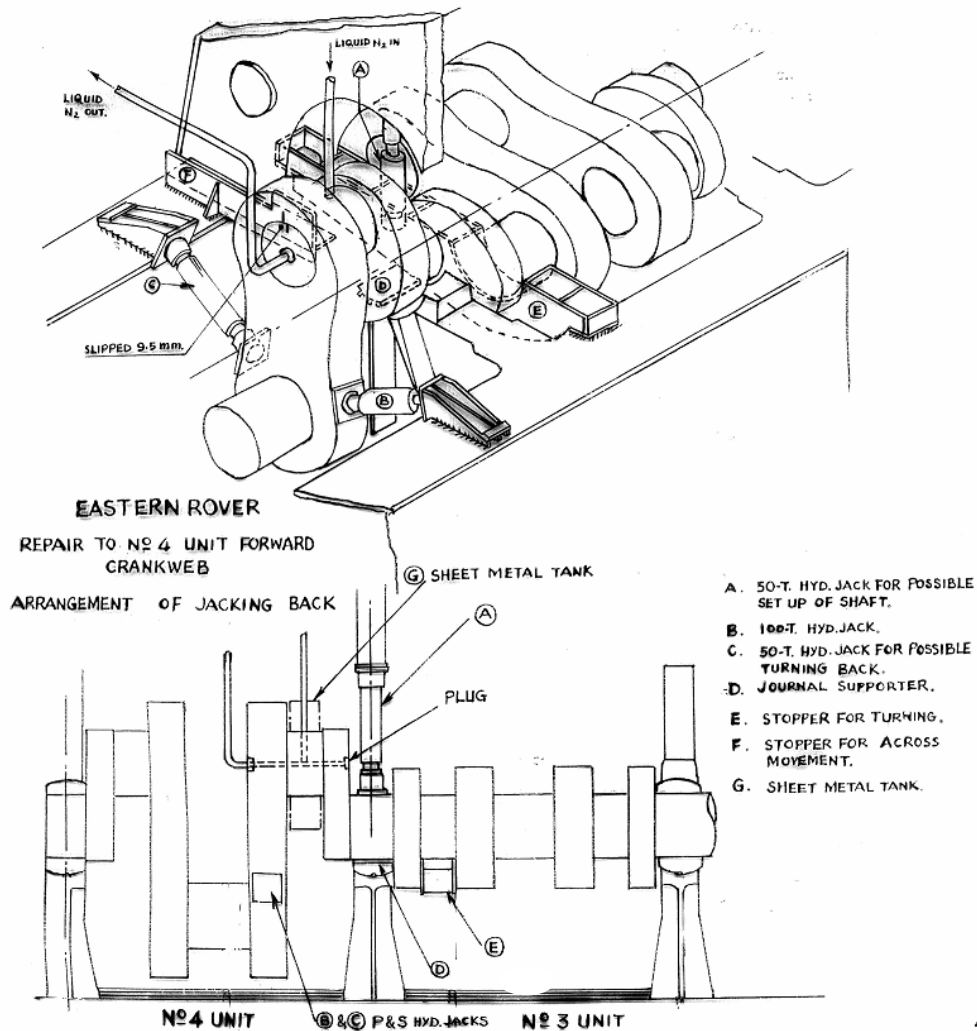
Figure 6. Repair set up

Figure 6A. Repair set up continued.

Figure 6 shows how the crankshaft repair was carried out. Brackets made from mild steel plate were welded to the top flanges of the engine bedplate as buttresses for the hydraulic jacks that would be used. The 1mm thick sheet-metal tank was fabricated to surround the slipped side rod crankpin.

The purpose of the tank was to hold dry ice, to pre-cool all the parts associated with the crankpin, in readiness for the safe introduction of liquid nitrogen internally through the crankpin lubricating oil hole. Thereafter it would act as insulation. Roughly 30 hours of pre-cooling was done while other work went on. This included removal of the engine casing structure above the engine room, to facilitate the removal of the broken bottle guide assembly by floating crane and thence ashore by barge. The assistance of a shore based mechanical team of excellent and highly cooperative technicians, each wearing 'Honda' on their cover-alls, had been engaged. These friends arranged for the cast iron welding of the broken bottle guide assembly to be done at a workshop ashore. The crucial repair was carried out by a man very skilled in cast iron welding. Not only was the very difficult and extensive cast iron weld done superbly, it was done with such vertical alignment accuracy

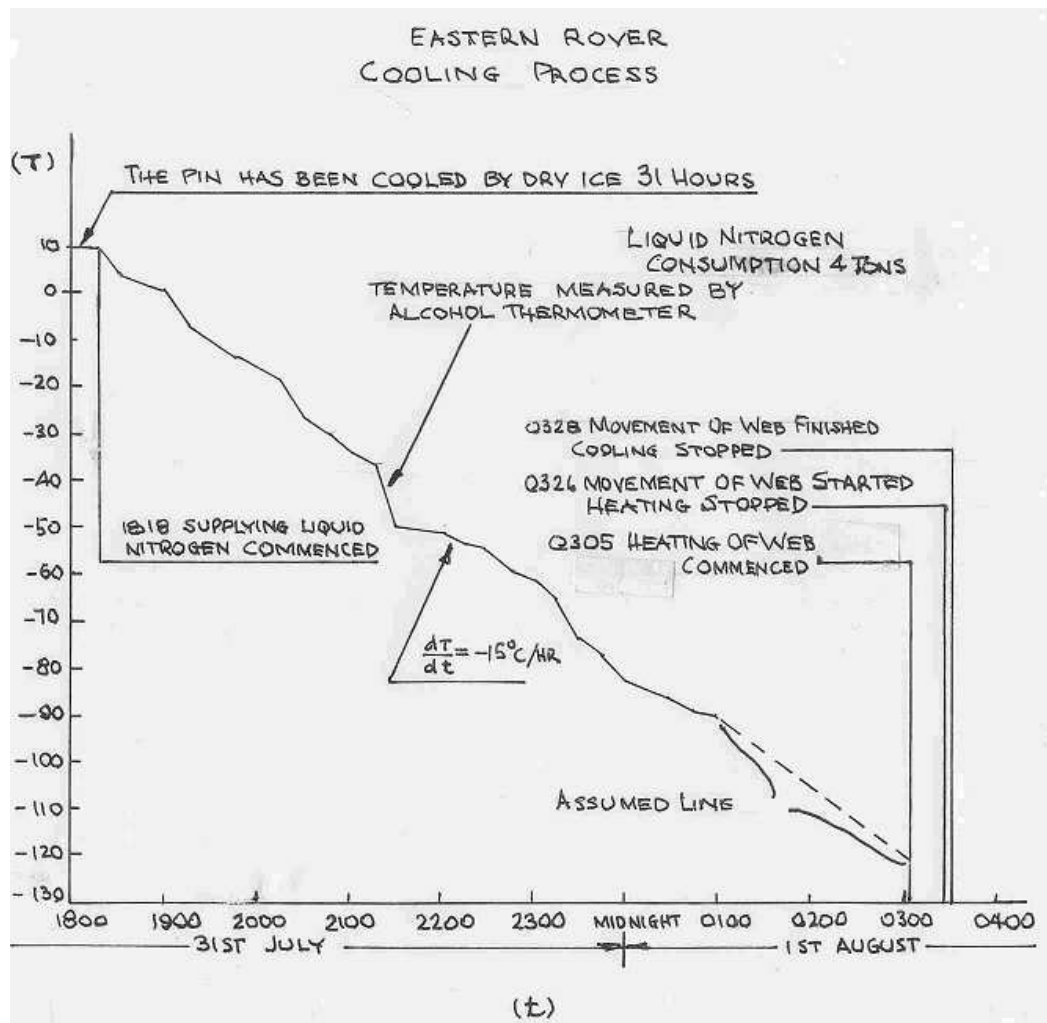
applying gentle heat to the web in the final cooling stages of the crankpin. Because the alcohol thermometer being used was only graduated to  $-90^{\circ}\text{C}$ , the temperature fall was plotted upon a graph to indicate approximately when the crankpin would reach the projected goal of  $-120^{\circ}\text{C}$ . The graph is shown in Figure 7.

Figure 7. Temperature plot

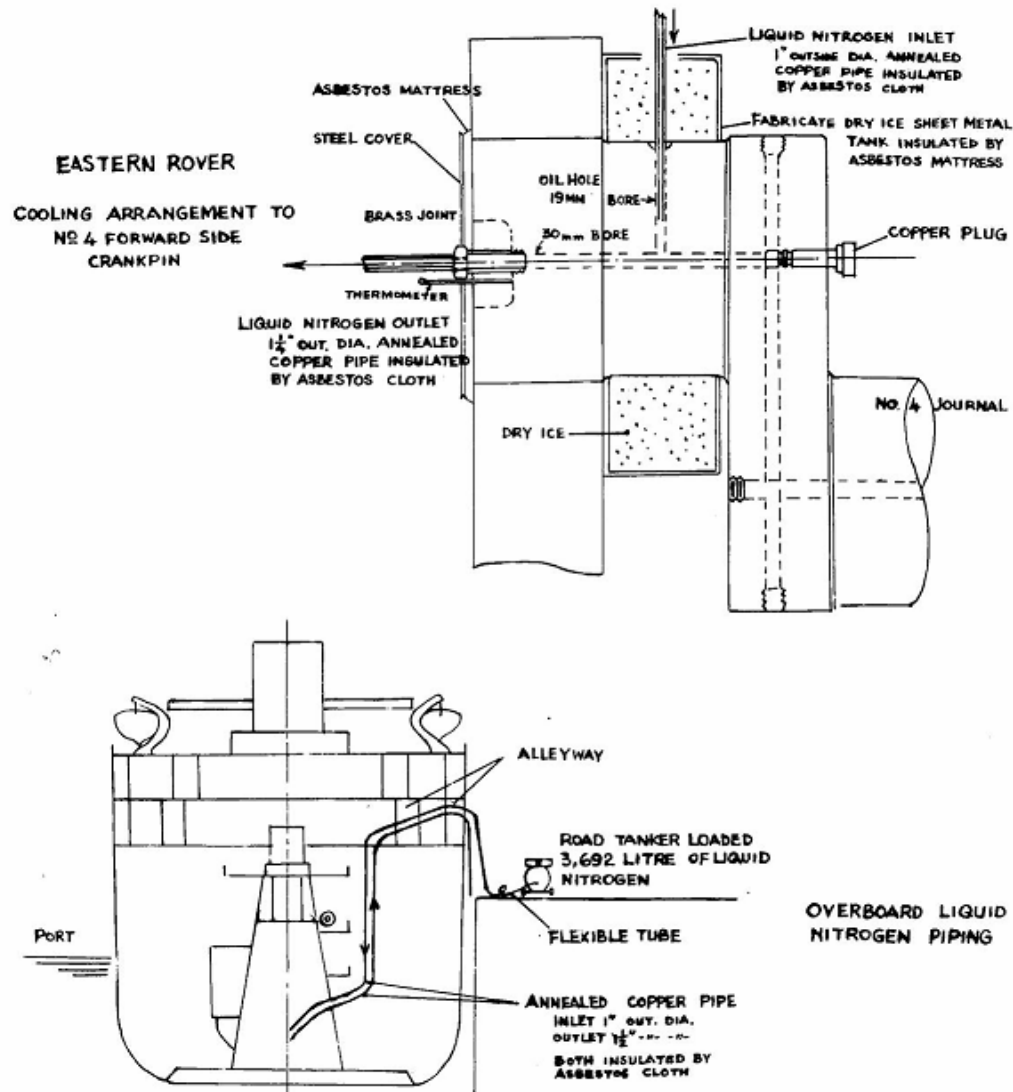
Figure 8. Liquid nitrogen supply connexions.

A copper plug was fitted into the drilled lubricating oil end hold of the side crankpin to isolate the pin from the rest of the system. A copper tube was forced into the lubricating oil hole in the crankpin surface. This was the supply pipe connexion for the liquid nitrogen. A copper outlet tube was fitted into the lubricating oil hole in the centre bore of the pin. Both tubes were connected by screwed nipples to lengths of 20mm and 40mm bore copper pipe which were taped with asbestos insulation and led out to the wharf. The vapour exhaust pipe was led down between the ship and the wharf. A circular plate of 5mm steel cut with a circular centre hole was used to cover the end of the crankpin with asbestos cloth put between the plate and pin end.

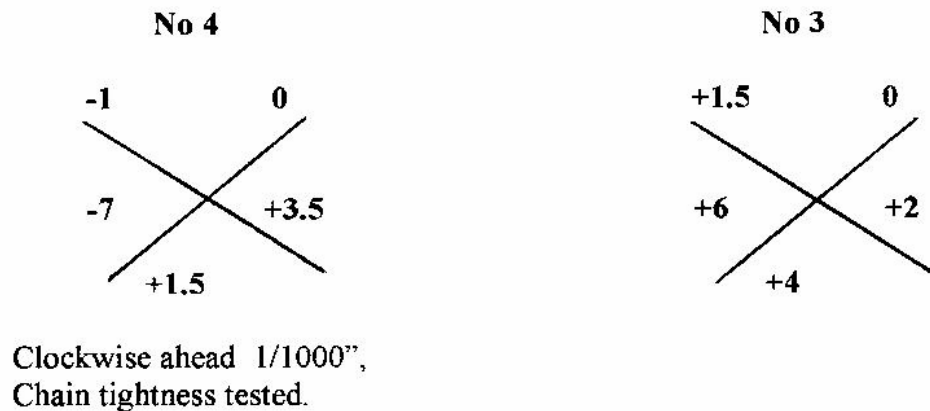
Figure 9 portrays the deflexions of No's 4 and 3 crankwebs after completion of the work, including the adjustment of main bearing heights, prior to Moji departure.

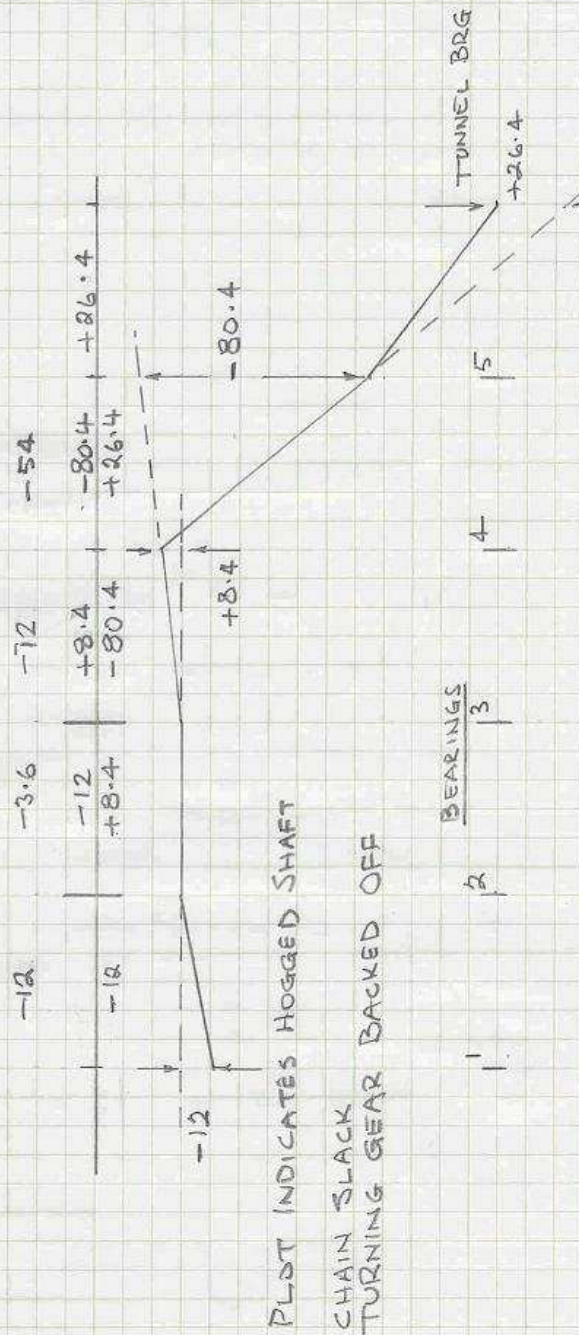
Figure 10 Main engine shaft alignment. Deflexions recorded arrival Kobe 5-8-68

Figures 10 and 11 portray the alignment of the crankshaft from web deflexions taken at ports succeeding the repair. Adjustments were made to the main bearing heights as shown. The plots indicated that being new, No 4 main bearing was high relative to the other main bearings. This could be expected.

However it was judged that the thrust bearing was being influential in the deflexion readings and so to test this opinion the bearing was raised by 0.030 inch shims and the deflexions retaken. A plot of these deflexions resulted in the further addition of 0.030 inch shims beneath the thrust bearing accompanied by the removal of 0.019 inch from No4 main bearing. The final acceptable position of the crankshaft is shown in Figure 11. Doxford engine builders require that their engines operate with positive deflexions within the range of +0.005 to +0.035 inch (0.125 to 0.9mm). Confirmation of the acceptable alignment can be seen from the later deflexion gauge readings recorded at Bangkok by the ship's engineers. Care must always be taken to factor into the work the alignment of the loaded hull, and therefore the distortion of the bedplate that occurs with changes of ship loading. This change of hull alignment corresponds to the changes in the vessels draught. Doxford LBD4 engine main bearings are uniquely designed, being mounted in spherical housings. This design enables the bearings to change their positions in the bedplate, to suit changes in bedplate alignment, thereby warranting special consideration. It will be seen from the above that alignment of a ship's main engine crankshaft by adjustment of the thickness of the white-metal bearings is considerably complicated. Nevertheless the author hopes that the deflexion graphing technique used by the author and depicted here, to realign the crankshaft and the bearings, has been explained or is otherwise sufficiently self explanatory to be readily understood and perhaps utilised by those whose job it is to continually monitor the main and auxiliary diesel engines of ships both big and small.

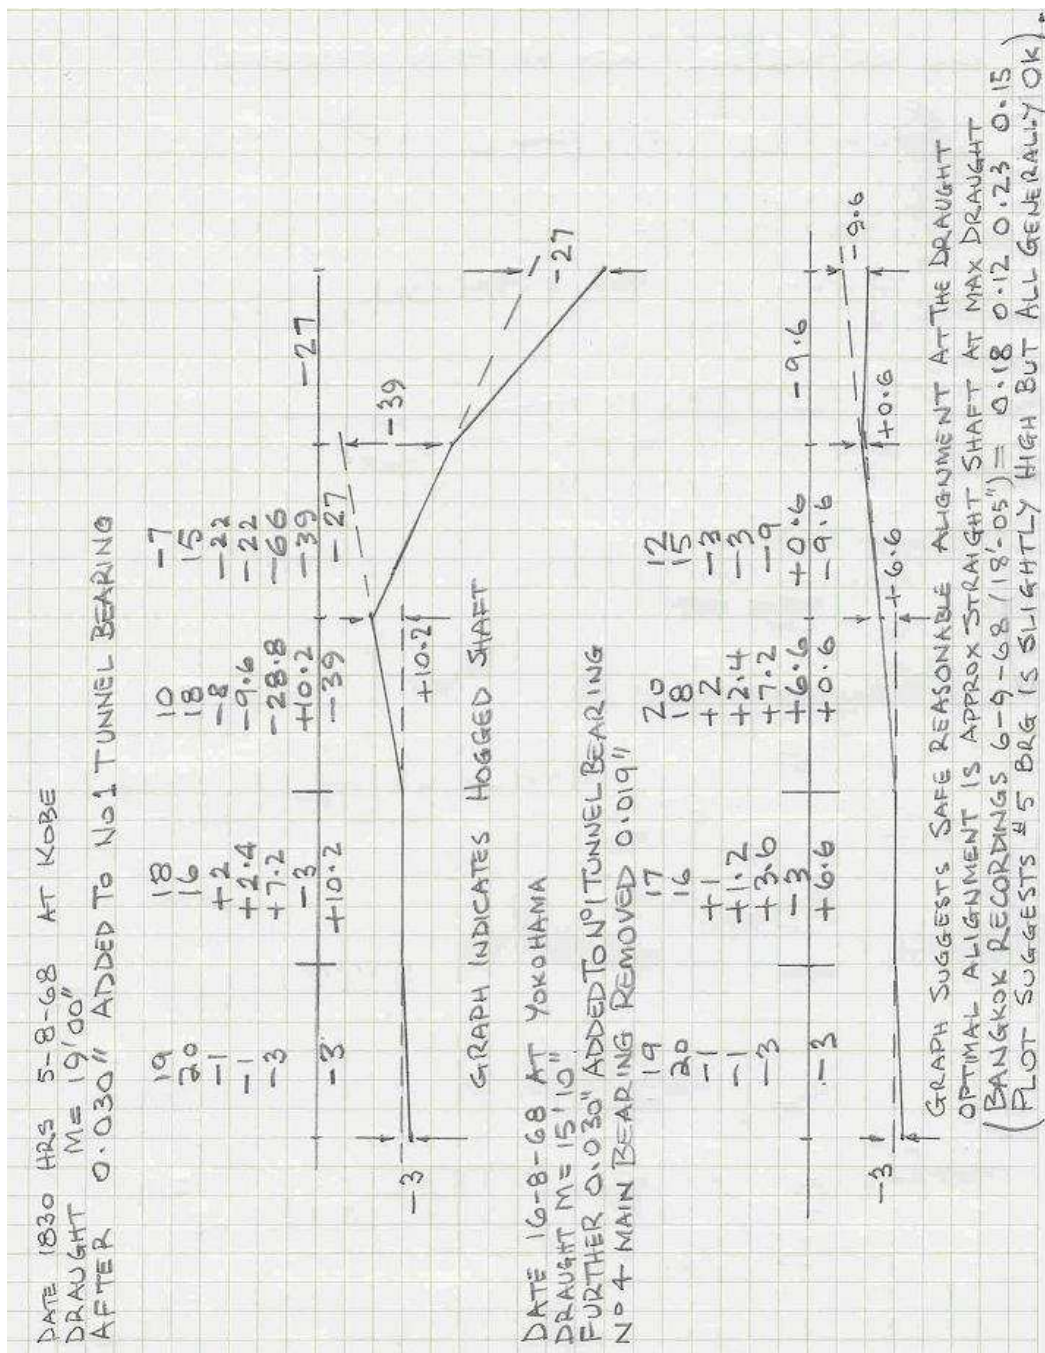
Figure 11 Main engine shaft alignment departure Kobe 5-8-68 after further work and also upon departure Yokohama 16-8-68, following further adjustments.
